HIGH STREET DRAINAGE PLAN

STORMWATER IMPROVEMENTS

TOWN OF PALMER LAKE

PROJECT NO. 2021-073.100

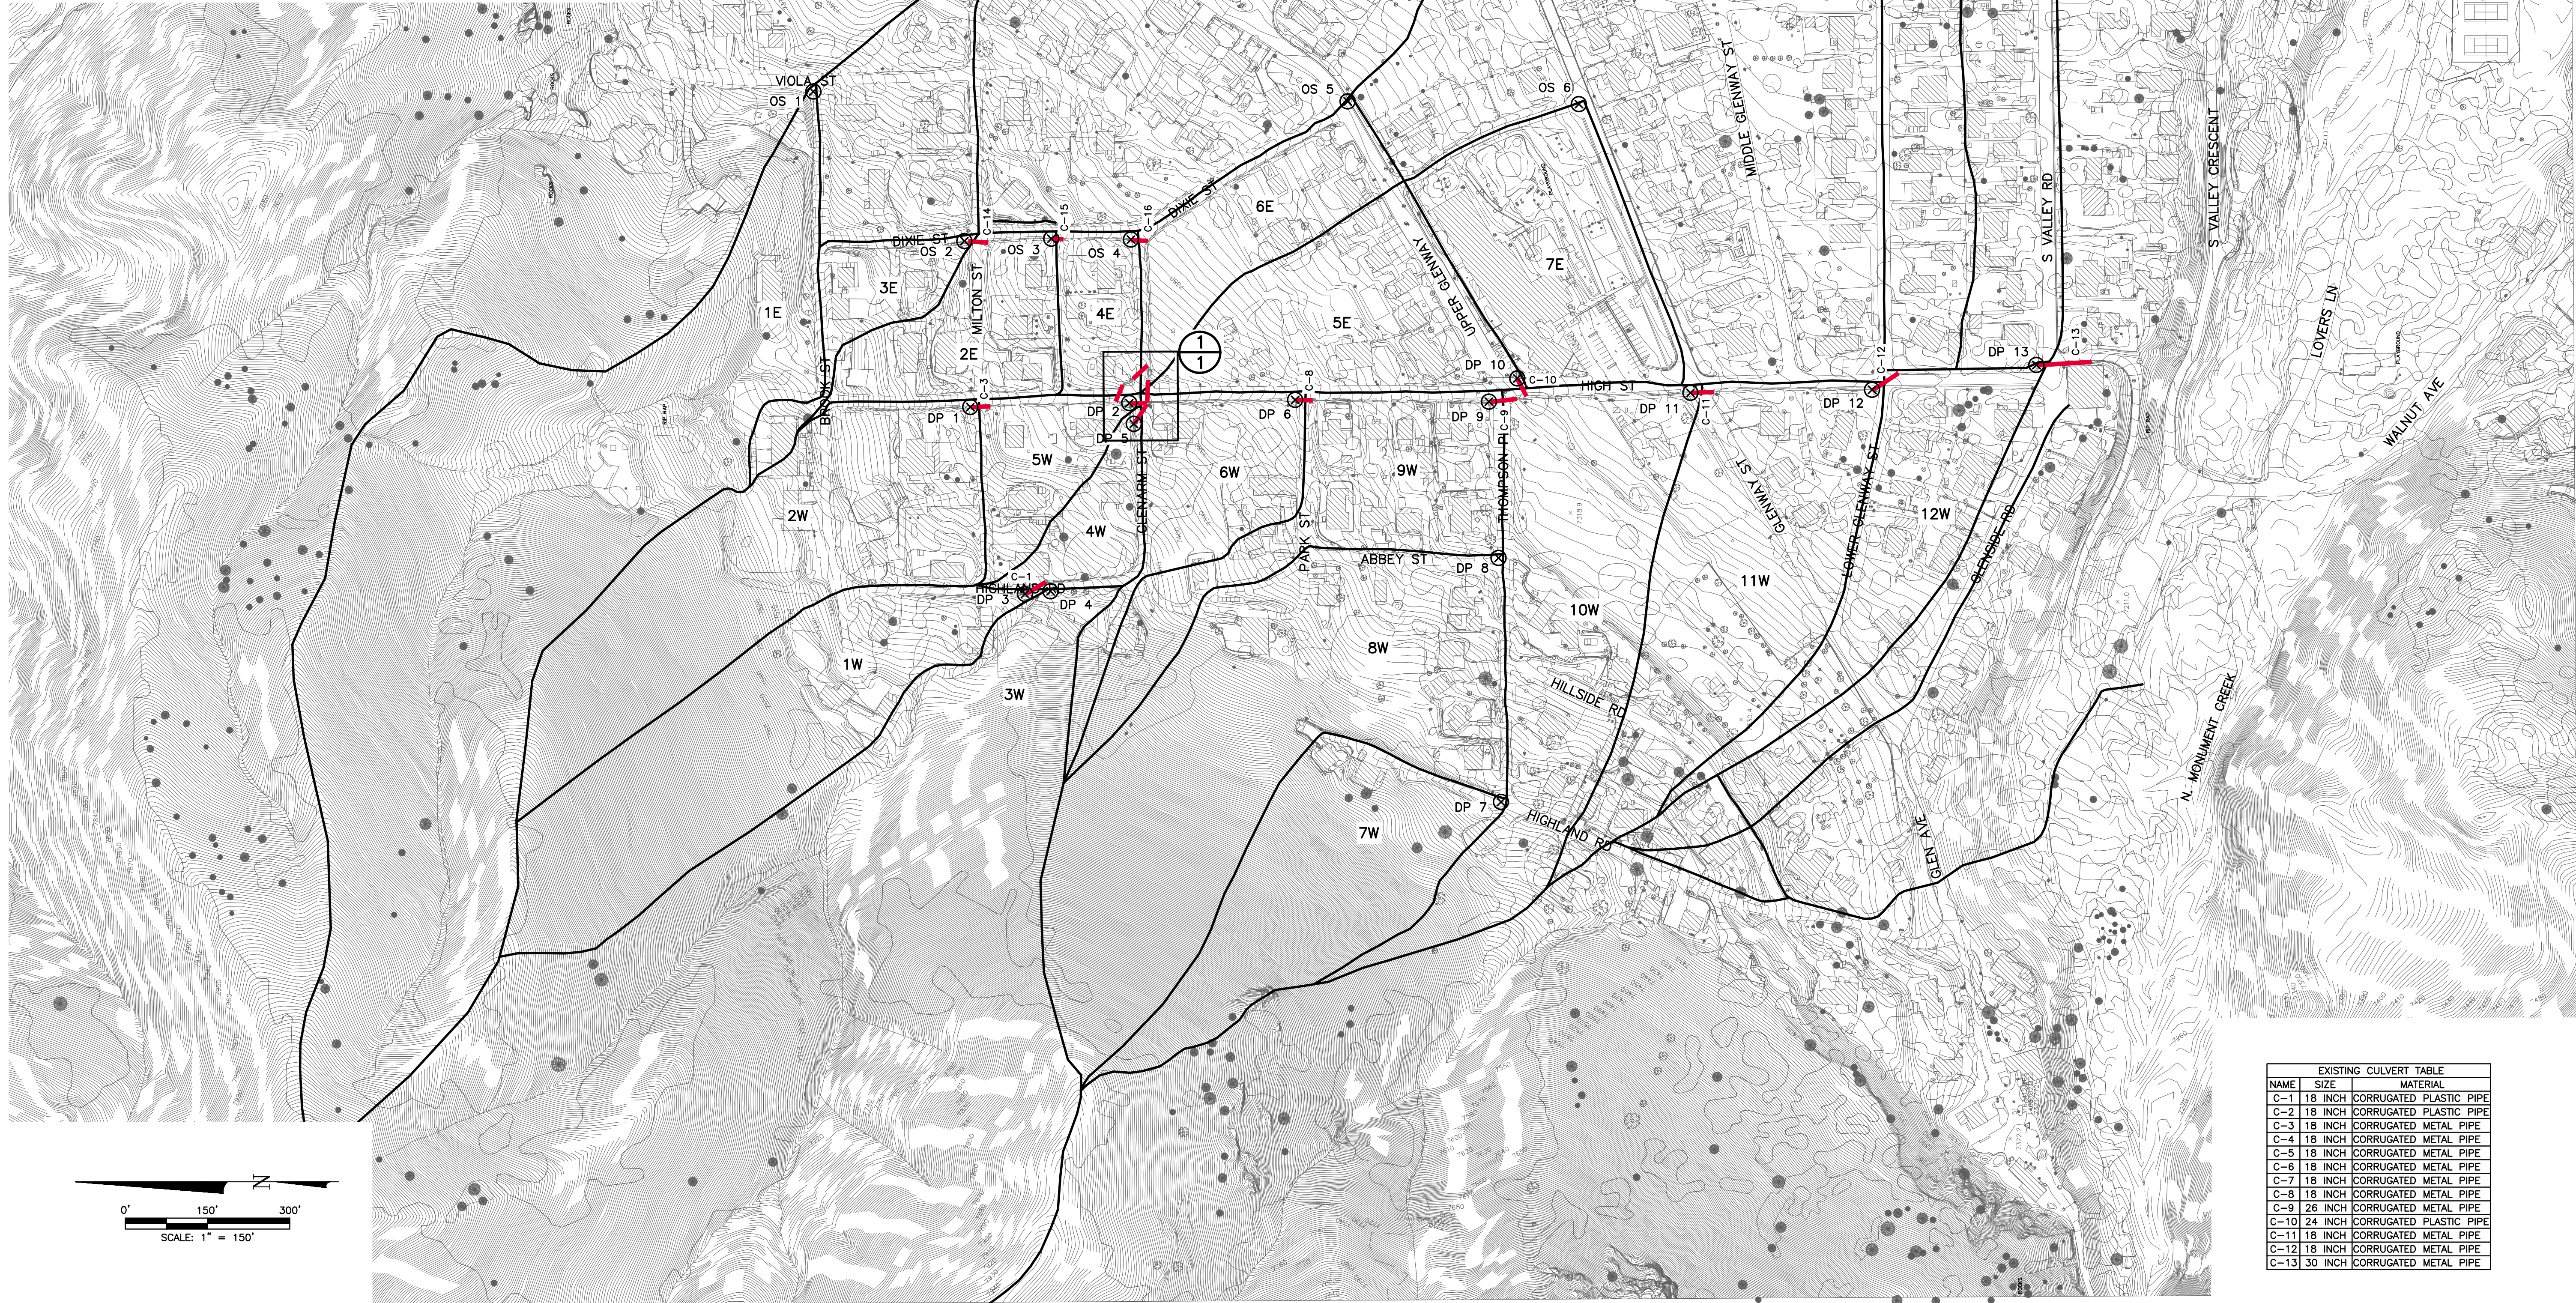
FIGURE 3
HIGH STREET DRAINAGE PLAN
EXISTING DRAINAGE BASINS
TOWN OF PALMER LAKE

EXISTING CULVERT TABLE		
NAME	SIZE	MATERIAL
C-1	18 INCH	CORRUGATED PLASTIC PIPE
C-2	18 INCH	CORRUGATED PLASTIC PIPE
C-3	18 INCH	CORRUGATED METAL PIPE
C-4	18 INCH	CORRUGATED METAL PIPE
C-5	18 INCH	CORRUGATED METAL PIPE
C-6	18 INCH	CORRUGATED METAL PIPE
C-7	18 INCH	CORRUGATED METAL PIPE
C-8	18 INCH	CORRUGATED METAL PIPE
C-9	26 INCH	CORRUGATED METAL PIPE
C-10	24 INCH	CORRUGATED PLASTIC PIPE
C-11	18 INCH	CORRUGATED METAL PIPE
C-12	18 INCH	CORRUGATED METAL PIPE
C-13	30 INCH	CORRUGATED METAL PIPE

In order to recommend drainage improvements to minimize stormwater runoff impacts, it was necessary to evaluate the existing drainage infrastructure. The existing drainage facilities, including, culverts, ditches, curb and gutter, and street sections, were inventoried during a field survey. The existing structure information has been used to assess the suitability of the facilities for adequate stormwater runoff control. All culverts are identified on Figure 3, enclosed in the back of this study.

This design point is located at the northwest corner of the intersection of High Street and Milton Street. The contributing basin is 2W. There is one 18-inch CMP culvert, C-3, that crosses south under Milton Street at this intersection. The existing culvert can convey 31.6 cfs at capacity assuming no backwater conditions. The calculated stormwater runoff for the 100-year storm event is approximately 5.8 cfs. The calculated stormwater runoff for the 50-year storm event is approximately 4.2 cfs. The calculated stormwater runoff for the 10-year storm event is approximately 1.6 cfs. Based on the surface profile and field measurements, the culvert can convey the calculated stormwater runoff from both a 10-year and 100-year storm event.
